CORRECT INSTALLATION AND MAINTENANCE WILL AVOID COSTLY BEARING FAILURES

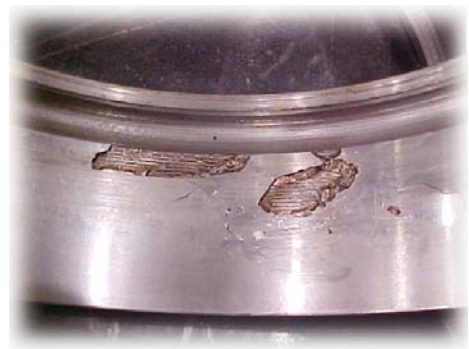
Figure 1 is a sample of babbitt failure through fatigue. Cyclic loading results in the propagation of cracks within the babbitt and when the cracks merge the babbitt material comes loose. The damage shown in Figure 1 is due to poor bonding of the babbitt and the steel backing. This is evident by the lack of tin on the steel surface. Correcting this type of problem will require replacing the bearing with one that

Figure 1: Babbitt failure due to poor bonding of the babbitt and the steel backing and fatigue. Source: TurboCare

has been certified as bonded through ultrasonic testing from a qualified bearing supplier.

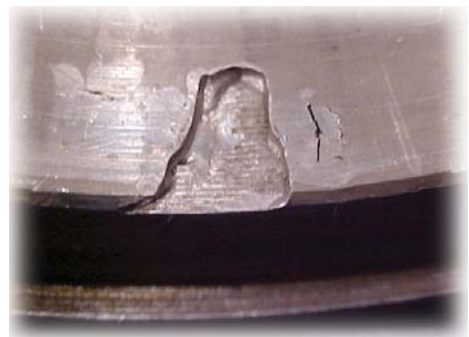
Figure 2: Fatigue from misalignment and high vibrations. Source: TurboCare

Another example of fatigue cracking is shown in Figure 2, but the nature of this failure is slightly different than that shown in Figure 1. Because tin is still evident on the backing material it indicates that the bond is still intact. The damage on one end of the bearing indicates that misalignment in conjunction with high vibration is the primary suspect. This type of problem can sometimes be resolved by correcting the source of the misalignment. However, it can also be resolved by replacing the bearing with one that is designed to compensate for the misalignment.

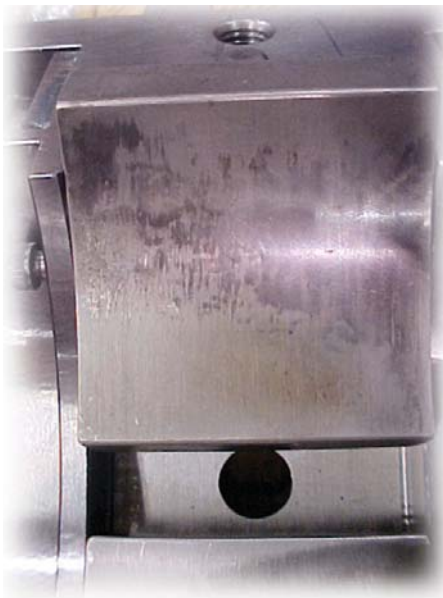
Figure 3: Triangular wear pattern from misalignment. Source: TurboCare

Misalignment is the most common source of premature bearing failure in high speed rotating equipment. It is also the most easily to identify. If the shaft and bearing are not square the load will be unevenly distributed along the bearing surface. A triangular wear pattern is the first clue. Figure 3 shows the wear pattern is noticeably wider at one end of the pad.

This particular design of bearing has the ability to tilt or rock in the circumferential plane, but not axially. As a result, the bearing is unable to align with the shaft misalignment. The dark patch to the left of the wear pattern is a sign of high temperature in the heavier loaded side of the pad. This is varnishing caused by overheating of the oil. Correcting the source of the misalignment, or replacing the bearing with one that is designed with alignment capabilities in the axial plane, are solutions for this problem.

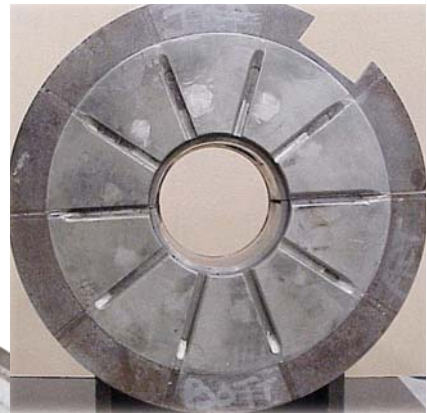
Figures 4a and 4b are examples of misalignment at the thrust bearings. Figure 4a is the active side bearing which is a tapered land thrust plate with no alignment capability. Wear on the babbit surface is highest on the top three pads and is progressively lighter in the circumferential direction. The inactive bearings shown in

Figure 4 a (top): Active side bearing. Wear from misalignment of the thrust bearings. Source: TurboCare.

These two bearings indicate a very high level of misalignment between the rotating shaft and stationary thrust bearings. Although correcting the source of the misalignment can rectify this problem, it can also be resolved by replacing the bearing with a self-equalizing tilt pad thrust bearing. **PE**

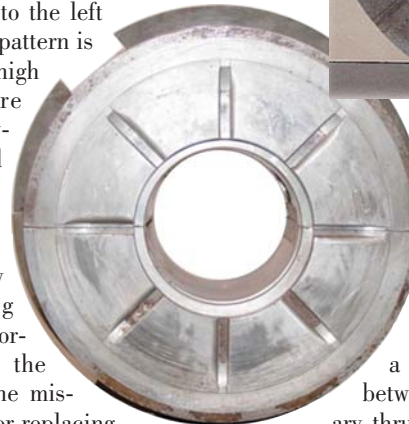
Figure 4b shows a similar pattern of wear, but the highest wear area is 180 degrees opposite the active bearing.

Figure 4 b (left): Inactive side bearing. Highest wear is 180 degrees from the active side bearing wear. Source: TurboCare.
